The 18-Inch Rule

By AT1(AW) Cora Purcell, VFA-81

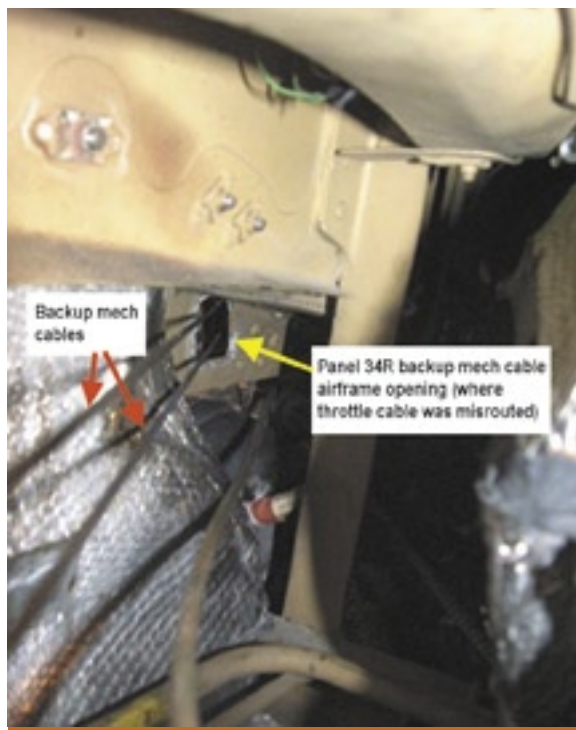
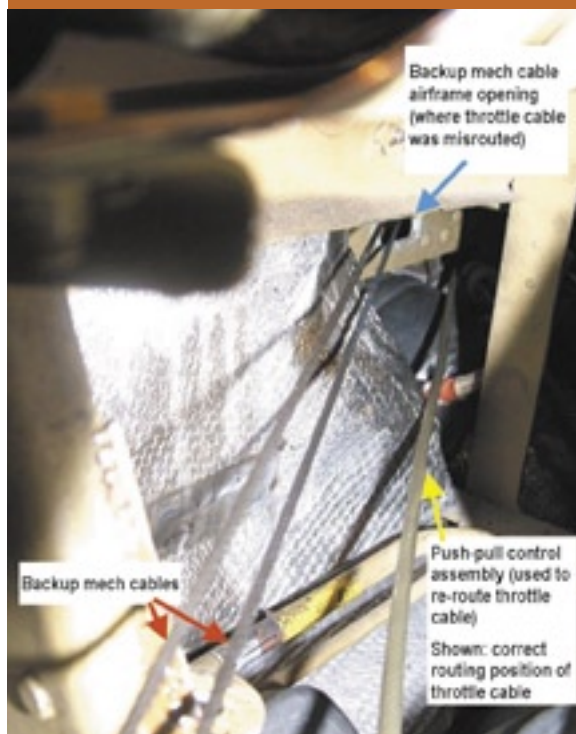
all portions of the back-up mech cables that were visible in any of these open panels (hence the 18-inch rule). While inspecting the cables in panel 34 right, he noticed that the middle throttle cable for the right engine showed signs of rubbing and chafing. Further inspection revealed a groove worn into the shielding around the throttle cable. In one place, the shielding was worn through, and the throttle cable itself was damaged. AD1 Lindsay thought, "This is not good!"

The middle throttle cable was routed through the horizontal-stabilizer, flight-control-cable cutout, along with the back-up mech cables. Petty Officer Lindsay believed the throttle cable was misrouted and this misrouting had caused the damage to the throttle cable. He checked the aircraft publications to verify his suspicions. The pubs did not discuss or show the specific routing for the middle throttle cable in panel 34 right. He conferred with his fellow ADs, and they agreed the cable was not routed properly. However, none of them could prove it with the current aircraft publications.

Fortunately, the Boeing representative was able to provide the technical drawings that proved the cable was routed incorrectly. The cable was repaired and re-routed correctly—underneath the horizontal stab cutout, vice through it.

Our quality-assurance division completed a naval aviation maintenance discrepancy report (NAMDRP) on this discovery. As a result, efforts are underway to revise the F18C-D Power Plant and Related Systems Maintenance Publication (A1-F18AC-270-310) to add an illustration showing the correct routing of the middle throttle-cable assembly in panel 34 right.

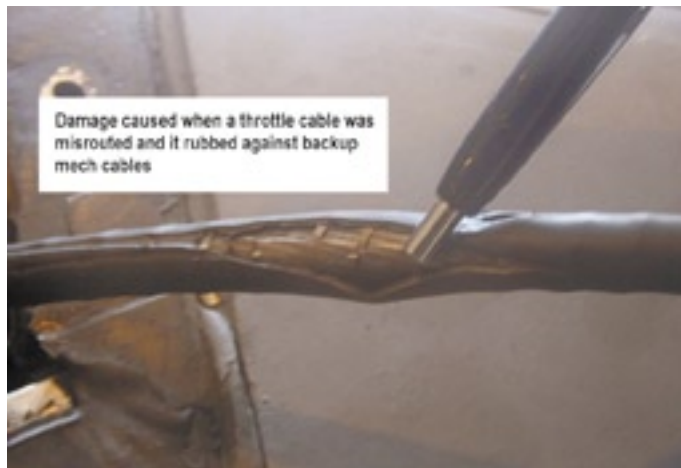
As part of the original maintenance gram, all AD1 Lindsay had to do was inspect the back-up mechanical flight-control cables in panels 41 R/L. He expanded that inspection into all the other open panels and associated cables, identifying a potentially fatal discrepancy. It was reported via the NAMDRP, thereby notifying other squadrons of this

potential hazard. Also, a publication is being revised to decrease the likelihood of this discrepancy ever occurring again.
